Docket No. SA-537

Attachment 7 – Test Plan and Results of Tensile Testing

777 Pack Release Mechanism Strength Test Plan

777 Pack Release Tensile Report 11-7-2013

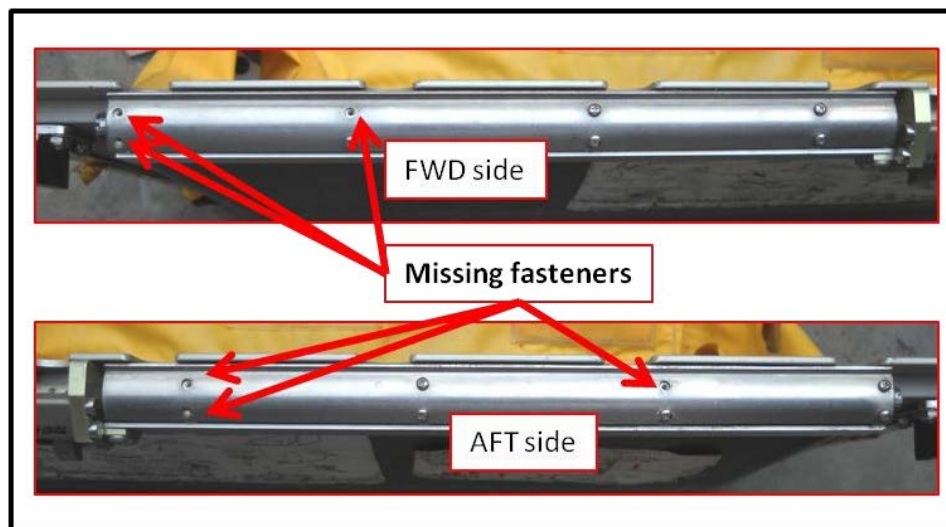
Figure 8. Modified Pin Shield Installation

- Modify one release assembly such that three fasteners are missing in each pin shield as shown in Figure 8, and the remaining fasteners are tightened hand-tight only.

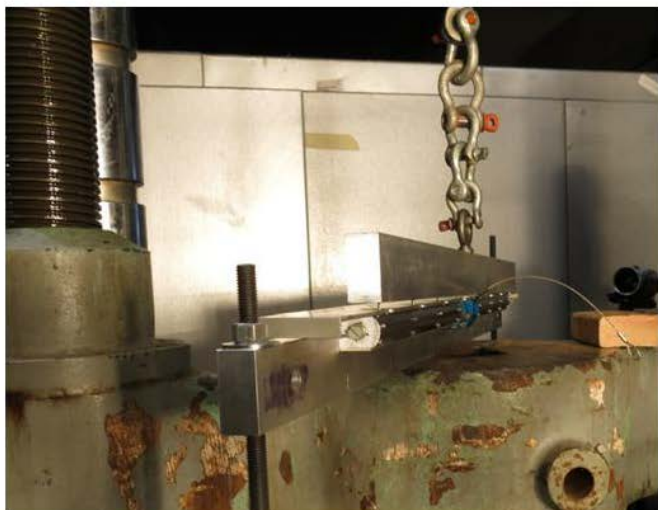
Inboard Baseline - Test #1

- Frame rate of 600 fps for video was too high, resulting in dark, out of focus images. Team agreed to reduce to 300 fps for the remaining tests.
- Damage seen in the tang area is consistent with that seen on some of the release mechanisms recovered from Asiana Flight 214.
- Shaft rotated approximately 90°
- 5 cables pulled out nearly simultaneously but the test was ended before any other cables could pull out.

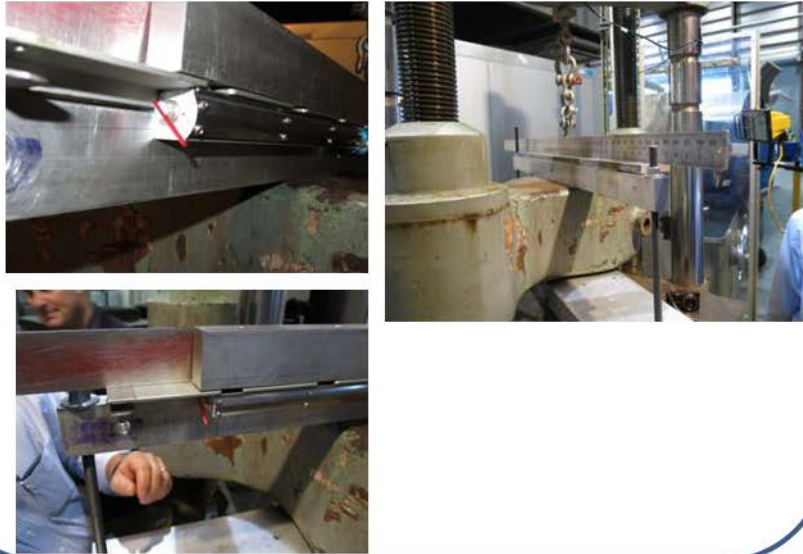
Inboard Baseline - Test #2

- Damage seen in the tang area is consistent with that seen on some of the release mechanisms recovered from Asiana Flight 214.
- Red plastic piece was added to the slot on the end of the release shaft as a visual indicator for the rotation.
- Shaft rotated approximately 90°
- Five cables pulled out nearly simultaneously. Two others pulled out as the test continued.

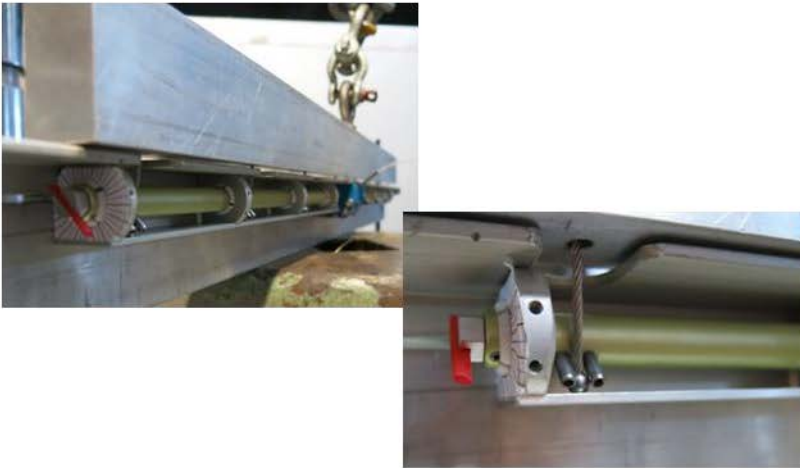
Inboard With Removed Pin Shields - Test #3

- Damage seen in the tang area is consistent with that seen on some of the release mechanisms recovered from Asiana Flight 214, though the damage is less than that seen on the previous tests that included the pin shields.
- The release shaft did not rotate as far compared to the previous tests that included the pin shields.
- All cables appeared to release simultaneously.

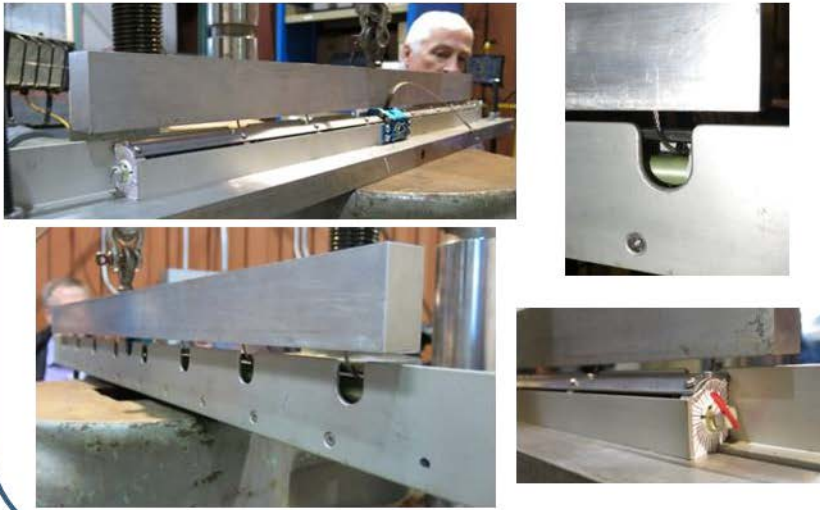
Download Baseline - Test #1

- Damage seen in the tang area is consistent with that seen on some of the release mechanisms recovered from Asiana Flight 214.
- The shaft rotated approximately 90°.
- The cables after the test had a distinct curl to them, which was not observed during the inboard tests.
- 5 cables pulled out simultaneously. Two others pulled out as the test continued.

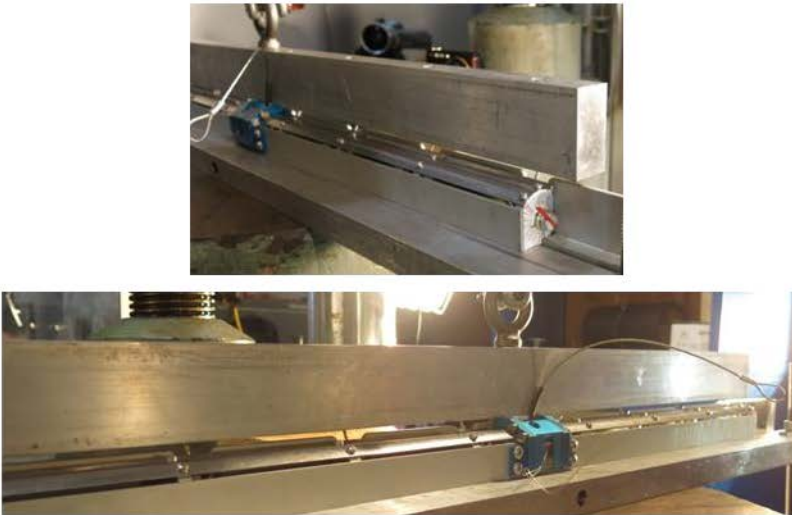
Download Baseline - Test #2

- Damage seen in the tang area is consistent with that seen on some of the release mechanisms recovered from Asiana Flight 214.
- The shaft rotated slightly less than 90°.
- Four cables release simultaneously. Three others released as the test continued.
- The release cables exhibited a curled appearance.

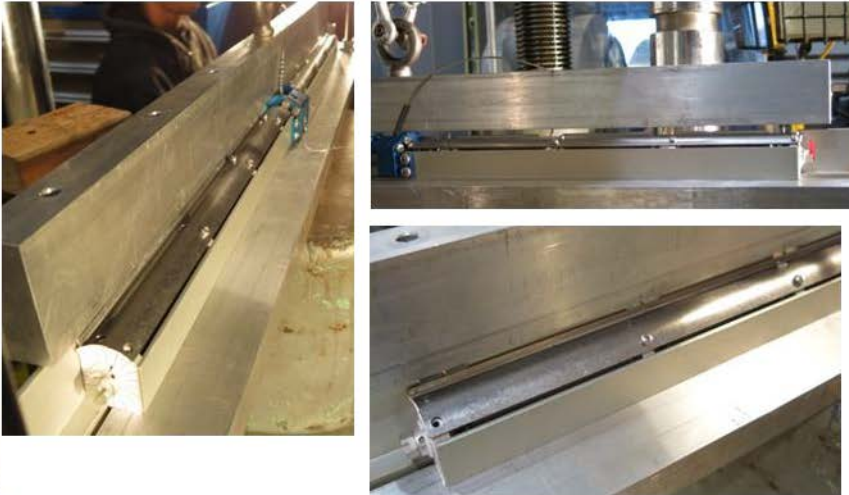
Download With Modified Fastening - Test #3

- Damage seen in the tang area is consistent with that seen on the DR 1RH release mechanism recovered from Asiana Flight 214.
- The shaft rotated much less than 90°.
- This test resulted in the lowest force measured to release the cables.
- The video shows the pin shields flexing, which creates space for the balls to pull through.
